Technical Inspection Report

of the technical inspection carried
out on:

Demolaan 1A
1234AB Demostad

Perfectkeur

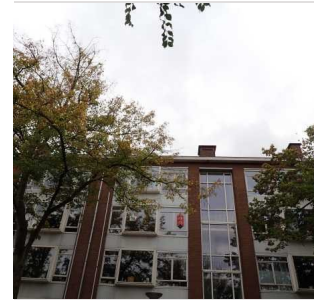
Foundation unknown

Foundation risk assessment

As far as this was visually observable during the investigation, no special features were found in the house that would suggest a problem with the foundation.

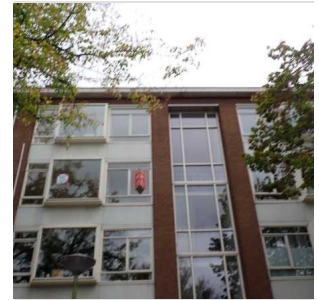
Crawl space and ground floor

During the investigation it appeared that there is no crawl space, or at least no access to the crawl space. This makes it impossible to make a statement about the condition of the underside of the floors, the situation under the floor and any pipes that may be present.

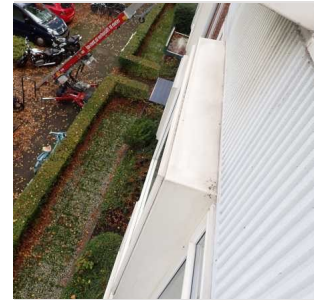
No unusual features were found on the concrete walls/facades. These are in sufficient condition and can function.

Assessment: **Good**

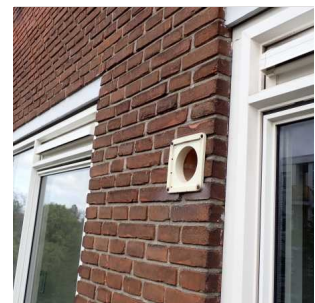
Facade construction - Brickwork

The condition of the masonry

1 - 5 years: € 55

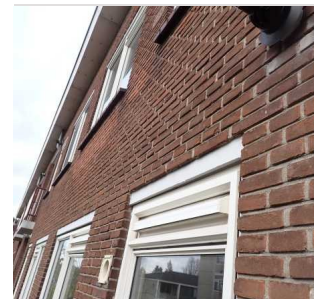
Brick headers, lintels and masonry

As far as visually observable, no deviations were noted in this structural part during the inspection. This element is in good condition and can function.

Assessment: **Good**

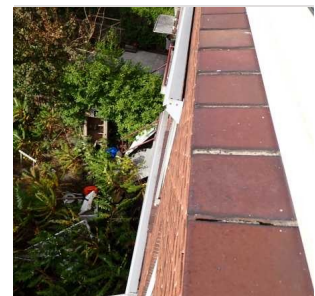
Water retaining facility

Window sill stones - en back

Assessment: **Sufficient**

1 - 5 years: € 140

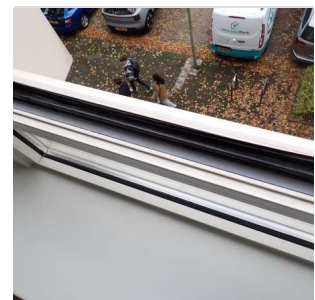
Frames - Glazing

Double glazing - front

Assessment: **Sufficient**

1 - 5 years: € 65

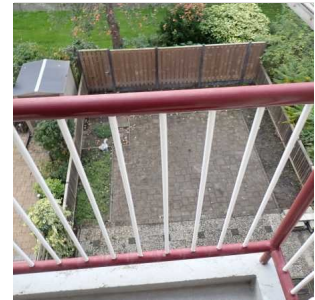
Balcony - Balustrade

Steel - en back

1 - 5 years: € 38

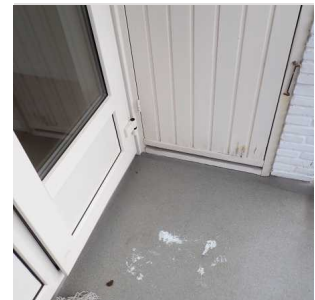
Balcony - Further findings on the balcony

Paintwork balcony cupboard

Direct (3 - 12 months): € 48

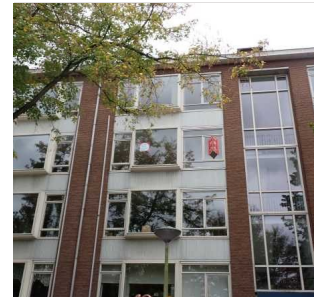
Gutters

The roof had not been inspected at the time of the inspection. The reasons can be various. In this case the roof is not accessible. No statement can therefore be made about the materials used and their condition.

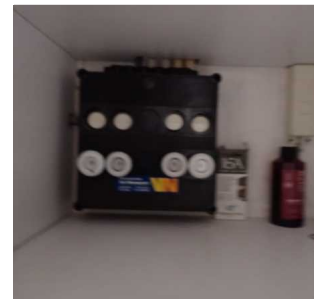
Electricity - Ground fault

Earth leakage circuit breaker is missing

Assessment: **Insufficient**

Direct (3 - 12 months): € 380

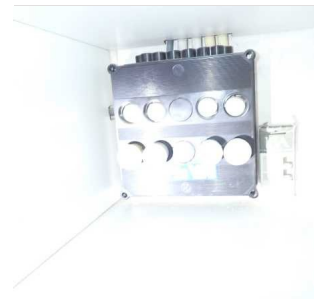
Electricity - Distribution box

Condition of the distribution board

Assessment: **Sufficient**

1 - 5 years: € 1.200

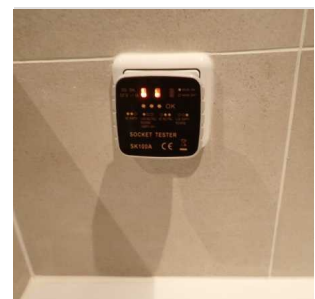
Electricity - Earthing

NO ●

Assessment: **Insufficient**

Direct (3 - 12 months): € 260

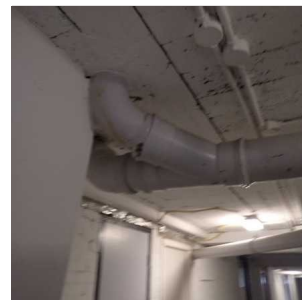
Sewerage / drainage

Cast iron

Assessment: **Sufficient**

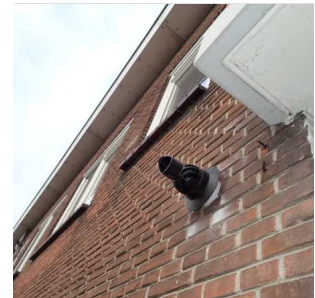
Flue gas discharge through the facade

Please note: the flue gas discharge from the boiler (or main fireplace/gas heater) runs through the facade through a horizontal outlet and is not subsequently discharged vertically to a higher level. This can lead to reduced air quality in the object when using open windows and/or the presence of (open) ventilation grilles in window frames. No costs have been budgeted to improve this situation.
