Summary of defects and risks

**Demolaan 1A
1234 AB Demostad**

Date of inspection 20 oktober 2025

Technical inspection report no. 123456

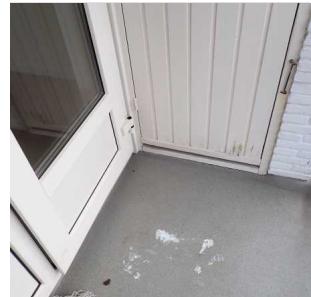
Paintwork balcony cupboard

The paintwork of the balcony cupboard is in poor condition. Maintenance will need to be carried out over time. When older layers of paint are removed, more wood rot may become visible. Defects in woodwork must be repaired. We assume that simple recovery is possible. Please seek advice regarding the paint system to be applied.

Assessment:: **Insufficient**

direct (3 - 12 months): € 48

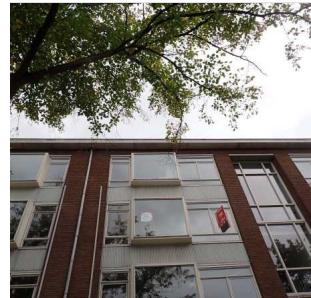
Roof inspection not possible

During the investigation, the roof was not or insufficiently inspected. The causes for this can be diverse, such as the height of the roof, the finish of the gravel layer or the presence of water on the roof. As a result, no judgment can be made about the structure and the general condition of the roof. In addition, any facilities, such as roof penetrations, chimneys and similar elements, were not or only very limitedly inspected.

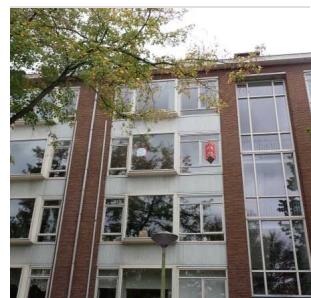
Not reachable

The roof had not been inspected at the time of the inspection. The reasons can be various. In this case the roof is not accessible. No statement can therefore be made about the materials used and their condition.

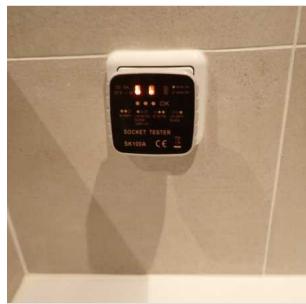
Earthing

To the extent that this limited measurement of protective earthing has been carried out, it does not appear to function sufficiently. It may be that part of the wiring is not connected at all or partly, and it may also be that the earth pin is not connected or is not even present. This makes the situation seem unsafe.

Assessment:: **Insufficient**

direct (3 - 12 months): € 260

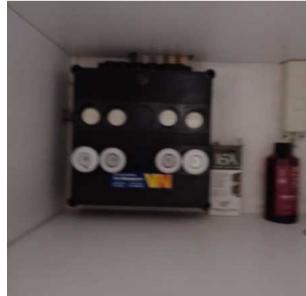
Earth leakage circuit breaker is missing

One or more residual current devices are missing. Since 1975, residual current devices have been mandatory for new or modified electrical installations in homes. This applies to all circuits, not just wet areas. While there is no requirement for installations before 1975, installing residual current devices is strongly recommended for safety reasons. Consult a certified installer for advice on the correct application.

Assessment:: **Insufficient**

direct (3 - 12 months): € 380
