Technical Inspection Report

of the technical inspection carried
out on:

Demolaan 1A
1234AB Demostad

Perfectkeur

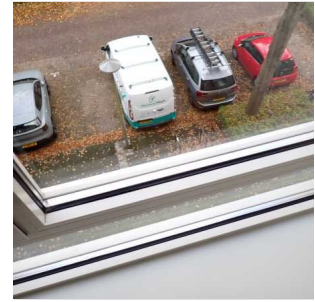
The frames are in sufficient condition. However, regular maintenance must be carried out, and any recommended repairs must also be carried out. Based on a sample, it has been determined that the rotating parts function sufficiently. The moving parts must be maintained and cleaned periodically.

Assessment: **Good**

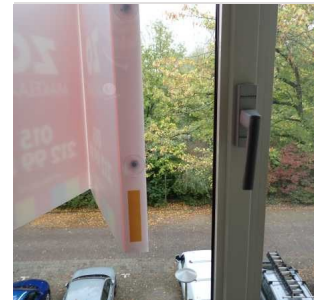
The hinges and locks have been checked. The material functions well and is well maintained. Regular maintenance must be carried out annually.

Assessment: **Good**

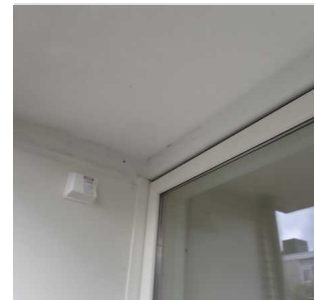
Frames

The frames are in sufficient condition. However, regular maintenance must be carried out, and any recommended repairs must also be carried out. Based on a sample, it has been determined that the rotating parts function sufficiently. The moving parts must be maintained and cleaned periodically.

Assessment: **Good**

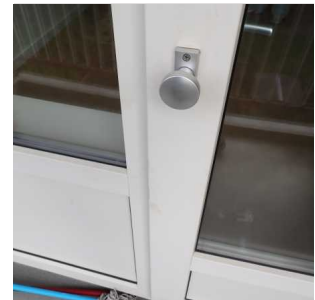
The hinges and locks have been checked. The material functions well and is well maintained. Regular maintenance must be carried out annually.

Assessment: **Good**

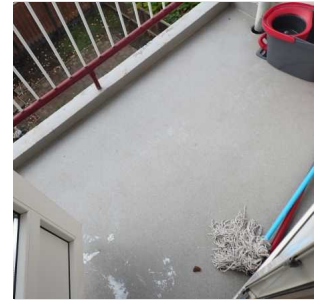
As far as visually observable, no abnormalities were found on the floor of the balcony during the inspection. This part / facility is in good condition and can function.

Assessment: **Good**

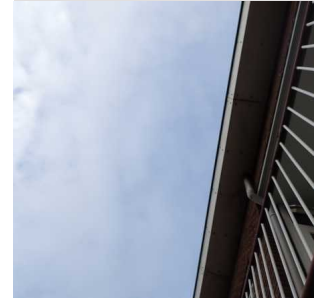
No defects were found on the overhangs/fascia. The whole is in sufficient condition and can function. Of course, regular maintenance must be carried out. This maintenance depends on the current condition, material and color.

Assessment: **Good**

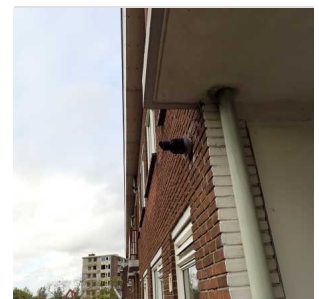
As far as visually observable, no deviations were noted in this part during the inspection. The rainwater drains are in good/sufficient condition. The mountings and drainage are sufficient. The whole can function as intended.

Assessment: **Good**

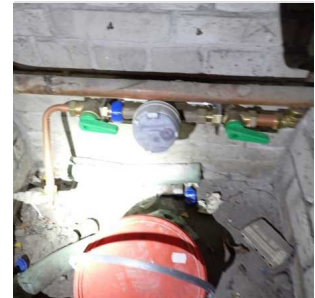
The following only applies if the water supply was not shut off during the inspection: The taps have been checked and the amount of water discharge is sufficient. The entire system functions sufficiently. No special features were found.

Assessment: **Good**

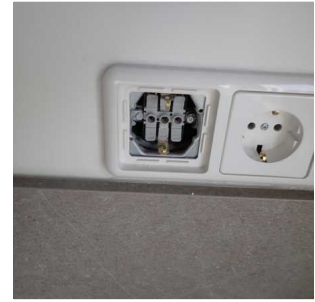
As far as visually observable, no deviations from the system were noted during the inspection. The wall sockets and switching material are in good condition.

Assessment: **Good**

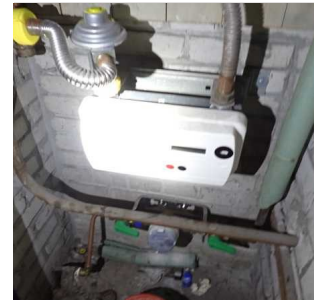
The condition of the installation

No defects were found in the gas system. The assessment is limited, but, as far as visible, is carried out as carefully as possible. The gas installation is visually inspected and therefore not inspected.

Assessment: **Good**

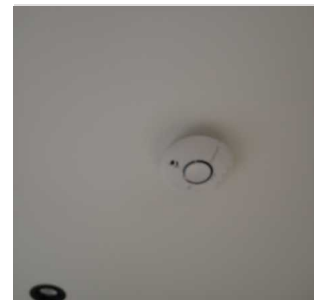
Safety installation - Smoke alarm

Sufficient present on every floor

There are sufficient smoke detectors in this object. There is a test button on the detectors. We advise you to test this for signal preferably twice a year. The detector requires further maintenance (cleaning) and may not be painted. Smoke detectors must be present on all floors.

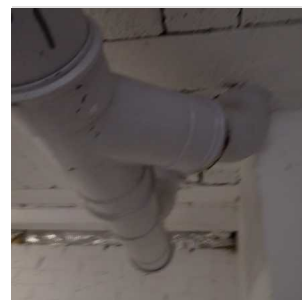
The sewers (and any down pipes) are in sufficient condition. As far as visible, the sewerage system functions sufficiently and there is sufficient slope. The confirmation is sufficient. No unusual features were found.

Assessment: **Good**

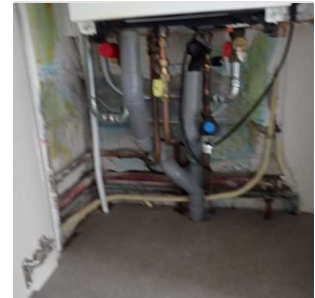
As far as visually observable, no abnormalities were found in the boiler during the inspection. This part / facility is in good condition and can function.

Assessment: **Good**

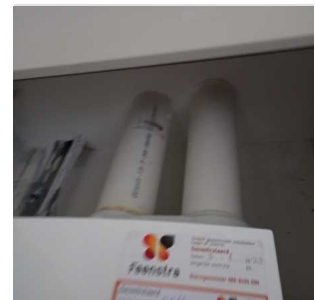
There are no defects in the mounting of the flue gas exhaust. The flue gas exhaust is in good condition and can function.

Assessment: **Good**

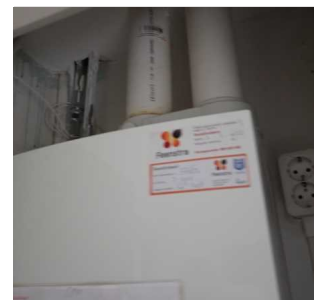
Sufficient maintenance has been carried out. This central heating boiler has been demonstrably inspected in accordance with the Gas Boiler Act. The inspection sticker is present. This promotes the technical lifespan of the system and has a positive effect on energy consumption. Maintenance must be carried out periodically.

Assessment: **Good**

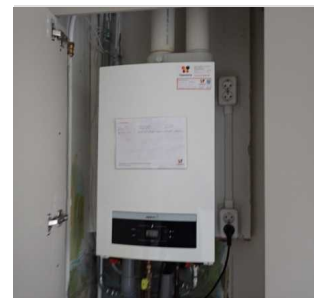
Technical lifespan

The heat generator has not yet reached its technical lifespan (15 years). It can last for a while with regular maintenance.

Assessment: **Good**

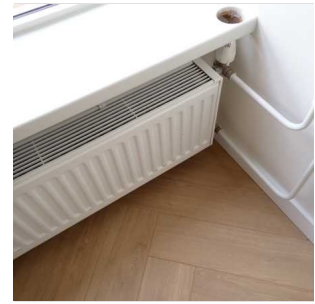
The condition of the radiators

As far as visually observable, no deviations were found in the system during the inspection. This part / facility is in good condition and can function.

Assessment: **Good**

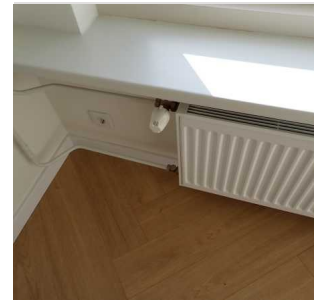
Valves

The valves, insofar as they have been inspected, are in satisfactory condition. No details found.

Assessment: **Good**

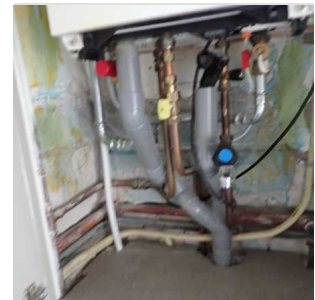
Condition

As far as visually observable, no deviations were found in the pipework during the inspection. This part is in good condition and can function. The pipework is sufficiently braced. Please note that this remains the case with any adjustments to the system.

Assessment: **Good**

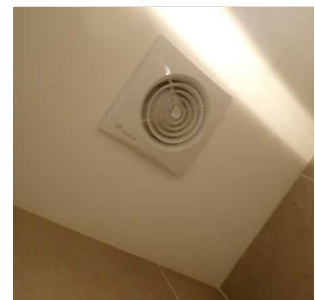
Functioning of the electric fan

The electric fans have been checked for their function and not for their extraction or intake capacity. These devices function sufficiently. No defects were observed. As far as perceptible and audible, the bearings, etc., are also still in good condition. There is no direct noise pollution.

Assessment: **Good**

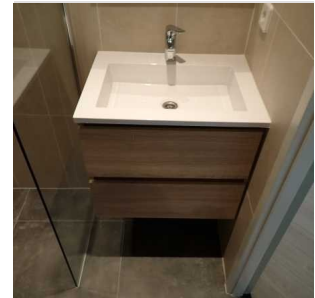
The bathroom and the available facilities have been visually checked for defects. The bathroom is in good condition and can function properly apart from regular maintenance of the water-retaining seals.

Assessment: **Good**

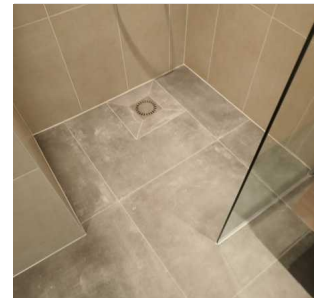
Condition of the floor finish

The finish of the floor is in sufficient condition. No unusual features were found. The finish appears to function sufficiently and is sufficiently waterproof.

Assessment: **Good**

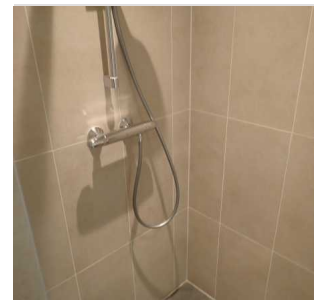
Condition of the wall finish

The finish of the wall is in sufficient condition. No unusual features were found. The finish appears to function sufficiently and is sufficiently waterproof.

Assessment: **Good**

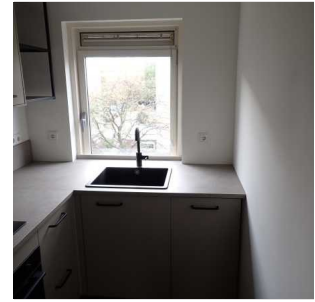
As far as visually observable, no deviations were found in the kitchen unit during the inspection. This part and/or this facility is in good condition and can function. The equipment present has not been checked for functioning. Therefore, no statement can be made about this.

Assessment: **Good**

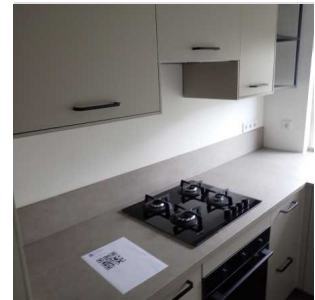
Functioning of hinges and locks

The hinges and locks of the kitchen cabinet doors are in sufficient condition. The whole can function well. There are no defects.

Assessment: **Good**

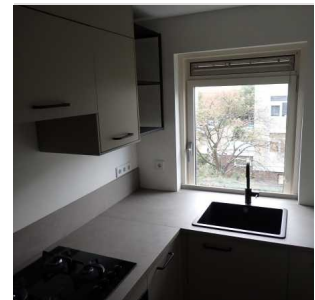
Kit finishes

The sealant finishes for the sink and/or worktop must fit seamlessly to each other and to the walls and/or in any case the connection between these elements must be watertight. In this case no defects were found.

Assessment: **Good**

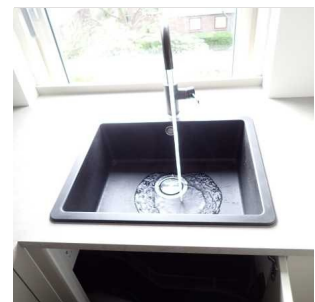
As far as visually observable, no deviations were noted in this part during the inspection. This part / facility is in good condition and can function.

Assessment: **Good**

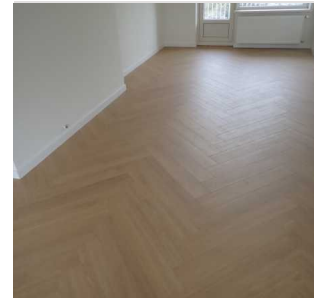
The floor is, as far as visually observable, flat and stable. No special features were found on the floor from above. No measurements were taken, the flatness was visually assessed.

Assessment: **Good**

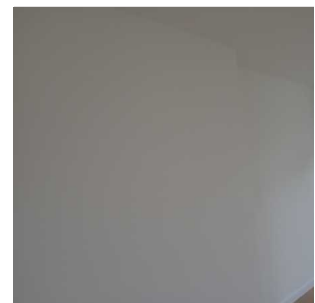
As far as visually observable, no deviations were noted in this part during the inspection. This part / facility is in good condition and can function.

Assessment: **Good**

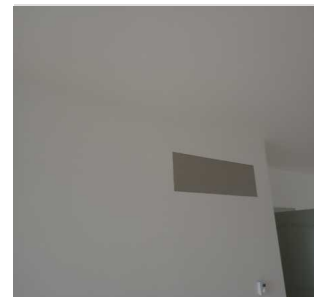
The condition of the plasterwork

In some places, if possible, the plasterwork has been tapped and it has been determined that the adhesion is sufficient. As far as can be observed during the inspection, the whole is in technically sufficient condition.

Assessment: **Good**

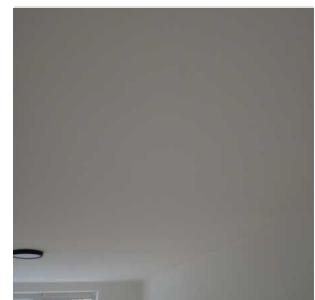
As far as visually observable, no deviations from the ceilings were noted during the inspection. This part / facility is in good condition and can function.

Assessment: **Good**

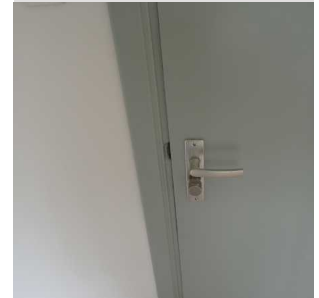
Hinges and locks

The hinges and locks function sufficiently. Regular maintenance must be carried out in due course.

Assessment: **Good**

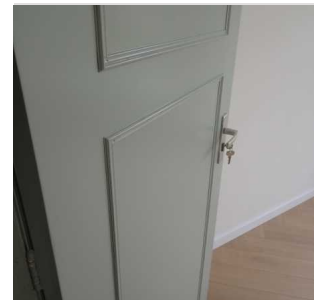
Paintwork window frames

The interior frames, windows, doors and paintwork are in sufficient condition. Regular maintenance of paintwork must be carried out over time.

Assessment: **Good**

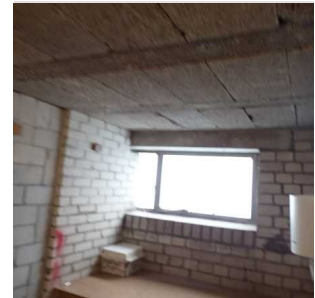
The storage rooms of the apartments are located in the basement of the building. No special features were found in the storage room of the apartment to be inspected.
